# The role of magnesium in concrete deterioration

Guoliang Gan  
*Iowa State University*

**The role of magnesium in concrete deterioration**

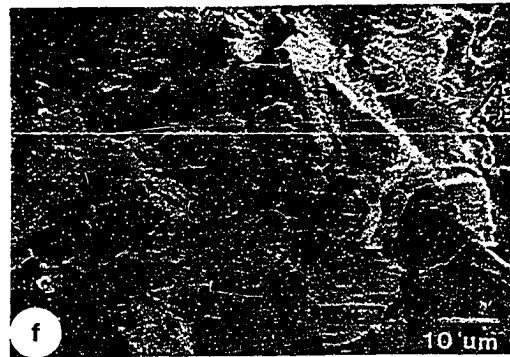
**Figure A3** SEM and light micrographs of Sundheim, Paralta and Smith quarry concretes.

**a.** SEM micrograph of a section through durable Sundheim quarry concrete. Many small spherical to sub-spherical grains with concentric lamination (representatively shown by arrows) are present in the cement paste. The concentric structure is not easy to see here because of low magnification. EDAX data indicate that the major components of these grains are Ca and Si, possibly suggesting that they are calcium silicate hydrates.

**b.** SEM micrograph of a section through non-durable Paralta quarry concrete. Many small spherical to sub-spherical grains (representatively shown by arrows) with abundant micro-cracks are present in cement paste. These grains are possibly calcium silicate hydrates.

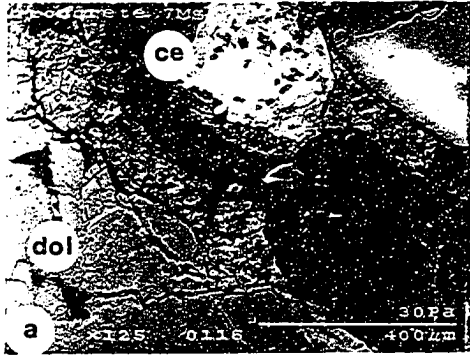
**Figure A14** Experimental deterioration of Paralta quarry concrete after MgWD and NaWD treatments.

**a-b.** Light micrographs, with plane-polarized light and cross-polarizer, of the interface in non-durable Paralta quarry concrete after MgWD treatment. The interface between aggregate and paste resembles that in untreated concrete as shown in Figures A3c-d and A4a-b. Zone Ee, the dark paste, exhibits severe cracking and decomposition, whereas zone De, the light paste rim, shows little cracking. Refer to Figure B21 for electron microprobe traverse at the interface.

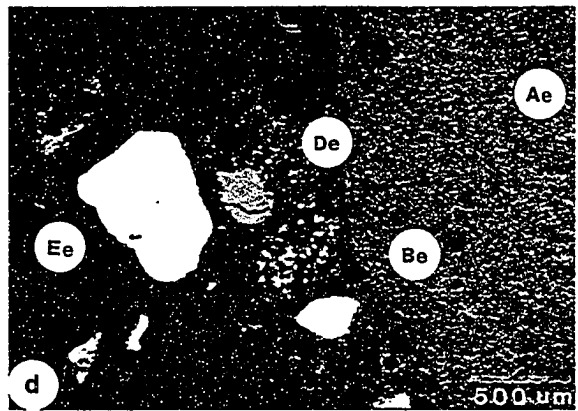
**e-f.** SEM micrographs of NaWD-treated Paralta quarry concrete. Figure A14f shows the enlarged lower-right portion of A14e which shows almost the same area as A14c-d. Zone Be, the dark dolomite rim, is less porous than porous than zone Ae, dolomite aggregate interior. No severe cracking or decomposition is evident in cement paste after NaCl-solution treatment. See Figure B23 for corresponding electron microprobe traverse, and Figure B24 for EDAX maps.

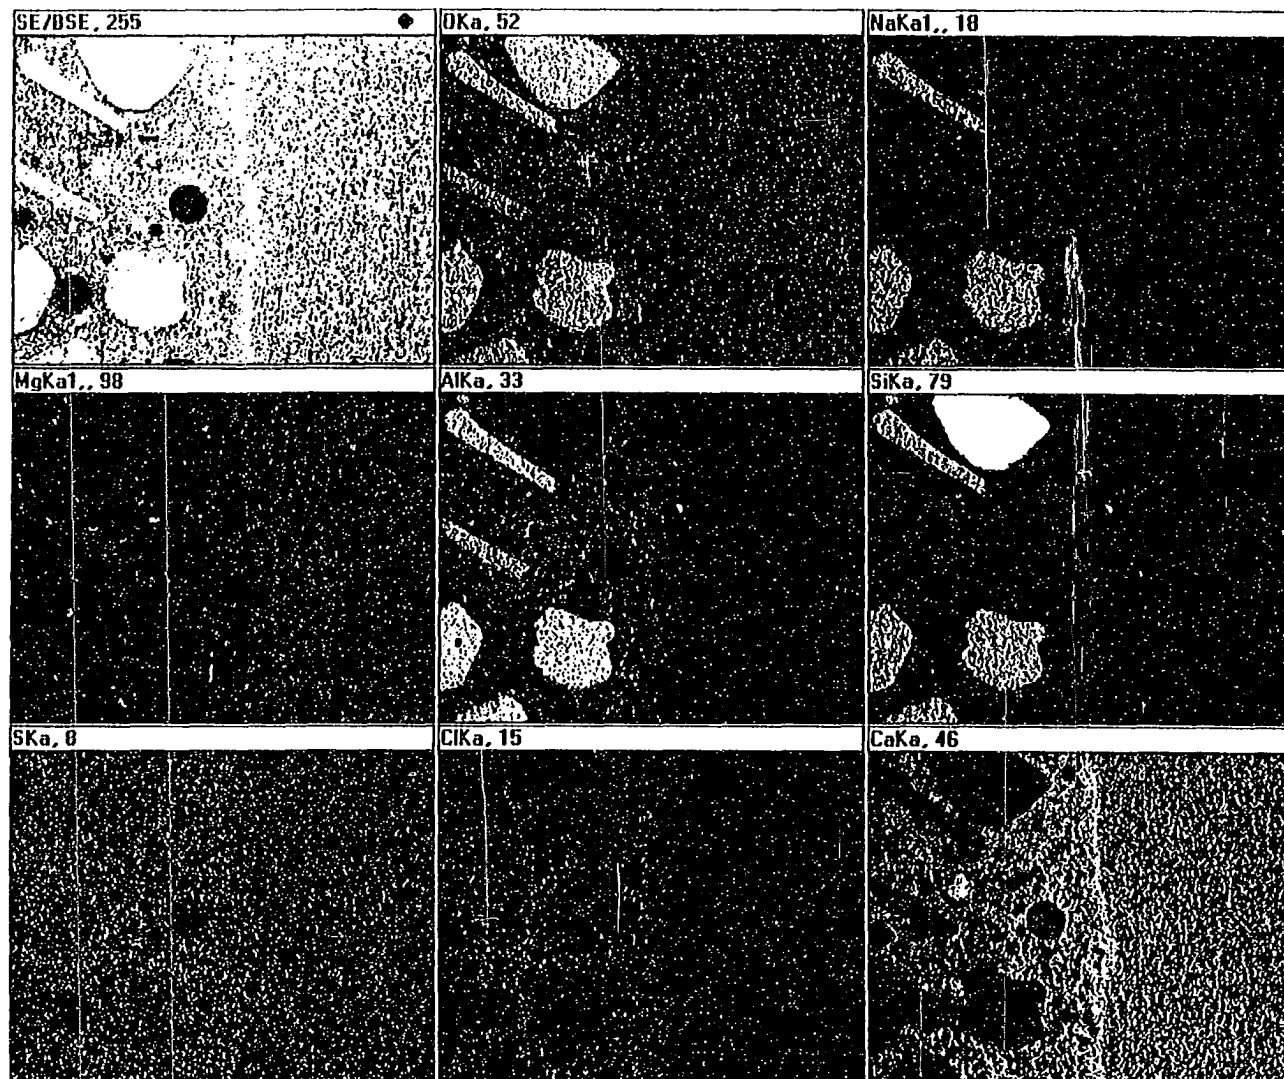
**Figure B24.** EDAX elemental maps showing the interface in Paralta quarry concrete after NaWD treatment. Interstitial voids in dolomite aggregate are filled with Mg-, O-rich (brucite) and Ca-, O-rich (calcite) phases. The light-colored paste rim is strongly enriched in Ca. The experimentally treated cement paste contains brucite and some Cl (chloride). Figure A14f gives corresponding SEM view.
